MICHIGAN DEPARTMENT OF TRANSPORTATION

STR 4035

BRIDGE SAFETY INSPECTION REPORT

Facility LONG LAKE ROAD	Latitude / Longitude 43.1102 / -85.2055	MDOT Structure ID 34200038000B020	Structure Condition Serious Condition(3)
Feature DICKERSON CREEK	Length / Width / Spans 88.9 / 29.5 / 3	Owner County: Ionia(34)	
Location 3.25 MI NE INT M44 & M91	Built / Recon. / Paint / Ovly. 1950 / / / 1999	TSC Grand Rapids(11)	Operational Status P Posted for load(33NNNN)
Region / County Grand(3) / Ionia(34)	Material / Design 4 Steel Continuous / 32 Multi Str Comp	Last NBI Inspection 10/18/2017 / JG14	Scour Evaluation 5 Stable w/in footing

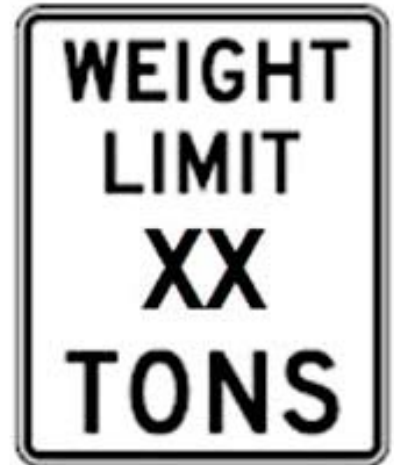
R12-1

Sample Sign

NBI Item 63 - Operating Rating Method	6 LFR in Rating Factor
NBI Item 64F - Federal Operating Rating	0.89
MDOT Item 64MA - Michigan Operating Method	6 LFR in Rating Factor
MDOT Item 64MB - Michigan Operating Rating	0.52
MDOT Item 64MC - Michigan Operating Truck	17
NBI Item 65 - Inventory Rating Method	6 LFR in Rating Factor
NBI Item 66 - Federal Inventory Rating	0.53
NBI Item 41 - Structure Open Posted Closed	P P Posted for load
NBI Item 70 - Bridge Posting	0 0 - 59% or less
Posted By	Gross Load
MDOT Item 141 - Posted Loading	33NNNN
MDOT Item 193A - Michigan Overload Class	
MDOT Item 193C - Overload Status
